Manhole Inspection Summary

Manhole # S29KK_009MH

Insp Date: **7/12/07 9:45 AM**

Location Address: **2000 MOUNT ROYAL TERR**

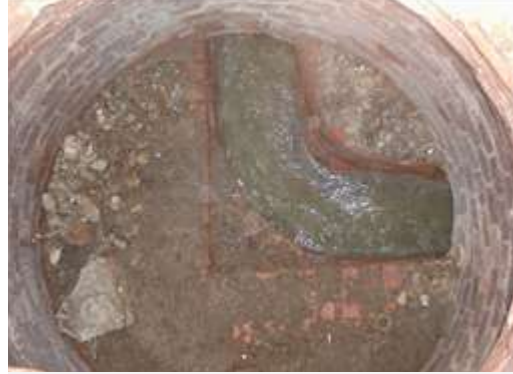
Top View

Surcharge ☒ **Evidence Of Surcharge** Depth: **1** (ft.) ☐ Active Surcharge Present

Evidence of surcharge - Bench debris.

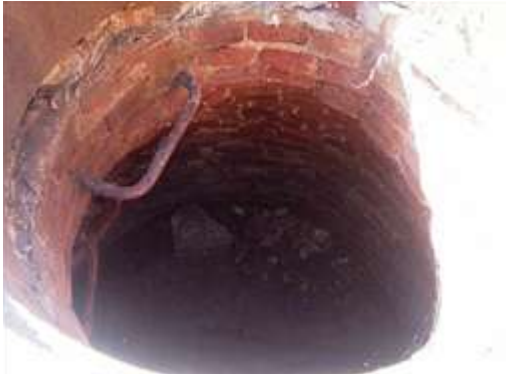
Defect

Frame leaks. Adjustment deterioration and infiltration. Corbel and Barrel infiltration - other side.

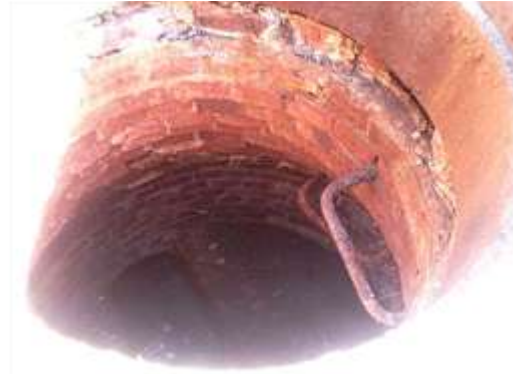
Defect

Frame leaks. Adjustment deterioration and infiltration. Corbel and Barrel infiltration.

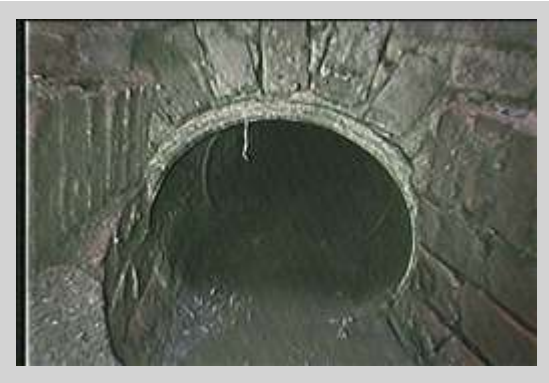
12 in. Circular Gravity Sewer Pipe Out @ 12 O'Clock

Barrel deterioration and infiltration. Channel deterioration.

Infiltration: **Evidence** Pipe Seal Cond: **Cracked**

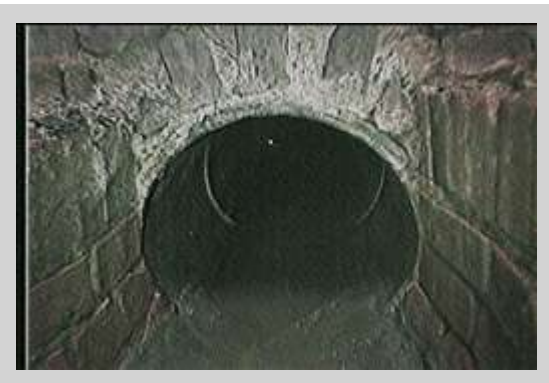
12 in. Circular Gravity Sewer Pipe In @ 3 O'Clock

Barrel deterioration and infiltration. Channel deterioration.
